Manhole Inspection Summary

Manhole # S45K2_019MH

Insp Date: **1/9/08 1:22 PM**

Location Address: **1435 Cherry St**

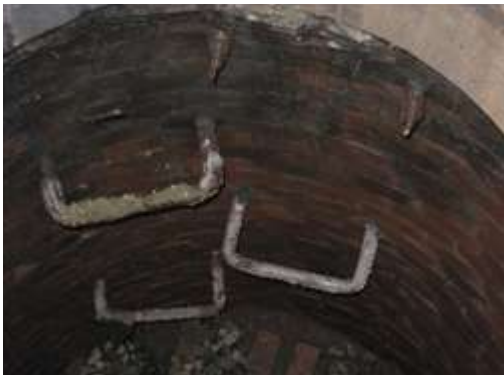
Count: **3** Missing: **1** ☐ Corroded

broken step

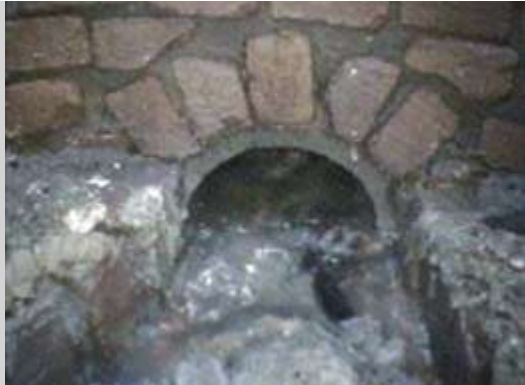
12 O'Clock Outflow

Pipe Height: **7.2** (in.) Rod and Bar (Angled)
Pipe Material: **Clay** ☐ Pipe Lined
Invert Depth: **8.36** (ft.) Flow Characteristics: **Fast**
Deposits: ☐ None ☐ Mud ☐ Sludge ☒ **Debris** ☐ Grease
Silt Depth: **1** (in.) Deposits Extent: **Medium**
Infiltration: **None** Pipe Seal Cond: **Sound**
